Structural Analysis of DEW Line Station DYE-2, Greenland 1983-1988

Michael R. Walsh and Herbert T. Ueda

June 1998

CRREL Report 98-3

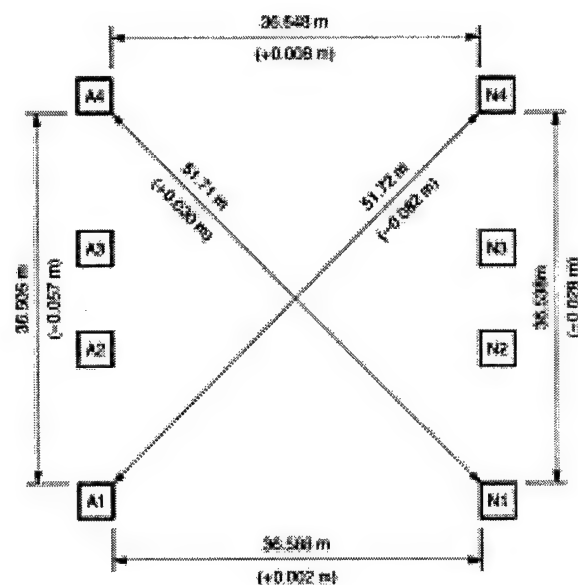
Finally, as the footings settle and the ice cap drifts (App. A), the columns move differentially with respect to each other (Fig. 10). This differential movement, in addition to the column out-of-plumbness mentioned above, sets up horizontal distortions in the column-truss system that can result in high loads at restraining points at the collars and in the building. High bending moments at the column bases are a result of these large horizontal loads. The horizontal distortion of the truss system may also be the reason why pinching and spreading loads sometimes appeared during sway bolt measurements (described in

Figure 10. Horizontal movement of columns at snow surface.

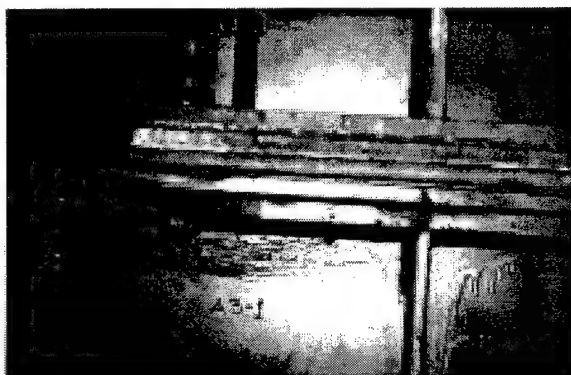
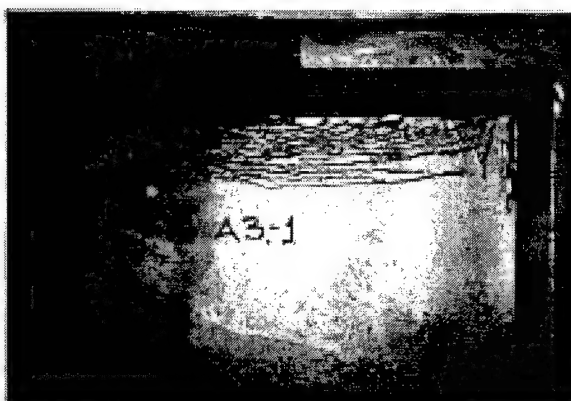
the next section). Leuder lines, distortions in the surface of a structural member indicative of localized yielding, were first observed in the supporting structure at the base of the columns below the footing support blocks in early 1988. These Leuder lines were thought to be evidence that high horizontal stresses, and therefore high moments, were being experienced by the columns. An example of Leuder lines is shown in Figure 11, which shows evidence of yielding below the support block of column A3.

Figure 11. Leuder lines: column A base.

- Footing tilts continued to increase as expected.
- There had been no significant increase in stress-induced Leuder lines in the bearing block supports on all column footings since June of 1988 (2 months). This was a qualitative assessment and indicated no further yielding in the supporting structure at the column bases over the summer. Later examination of photographic data showed

no increase in Leuder lines since the mini-life-extension operation in mid-1987, leading to the conclusion that the yielding had occurred during that work and not afterwards as previously thought.

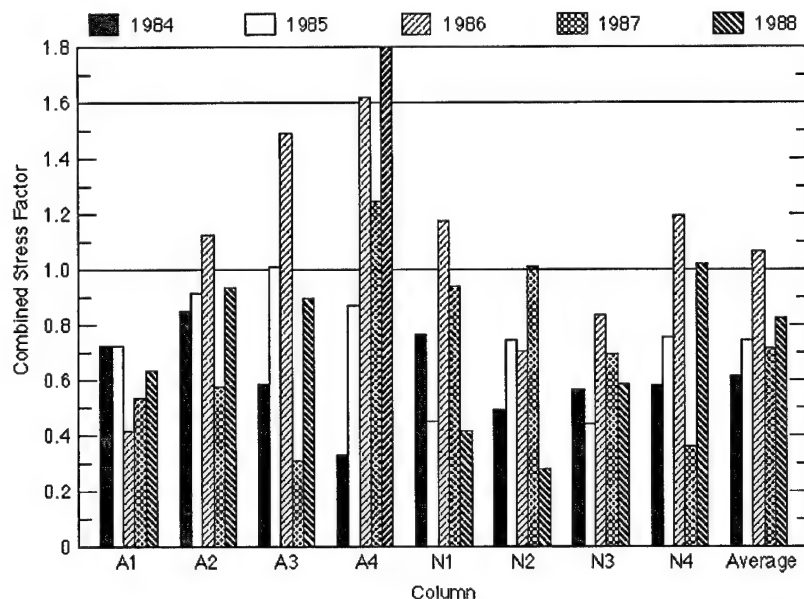
Figure 12. Summary of base level stress concentration factors: 1984-1988.

low, with an average base level combined stress factor (BLCSF) of about 0.61. BLCSFs are calculated loads on the column bases caused by stresses measured in the four collars of each column. There is no obvious pattern to the stress levels. None of the column BLCSFs exceed 1.00. In 1985, the stresses have become redistributed. The average BLCSF has increased to 0.71, with one column exceeding 1.00. Again, no pattern is obvious, although the A row is more heavily loaded than the N row.

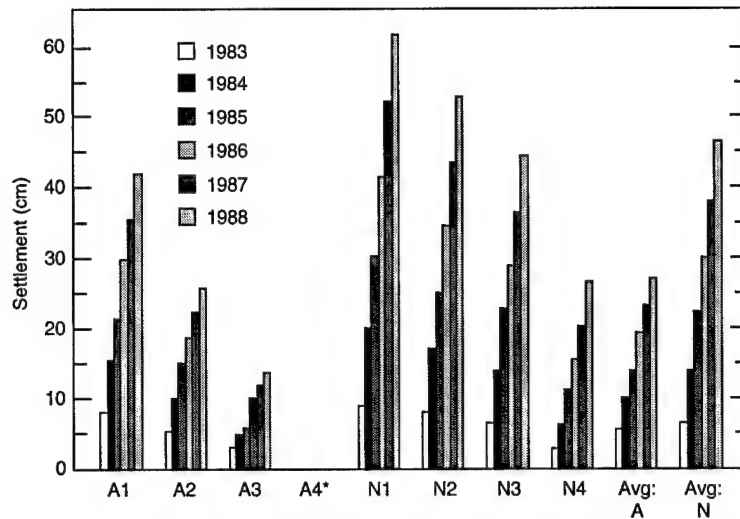
Figure 13. Footing settlements: 1982-1988.

at differing rates. Figure 13 shows the settlements of the A and N row of columns, as well as the averages of each respective row. Footing A4 was used as the datum point as this was the slowest settling footing and was used as the "baseline" footing previous to the move in 1982. Therefore no settlements are given for it.

From these figures, several observations can be made. The most obvious is that the N row is settling faster than the A row. The average rate of settlement of the N row with respect to A4 is 0.08 m/year. The settlement of columns A1 through A3 with respect to A4 is only 0.05 m/year. Footing settlement data can be found in Walsh (1992).

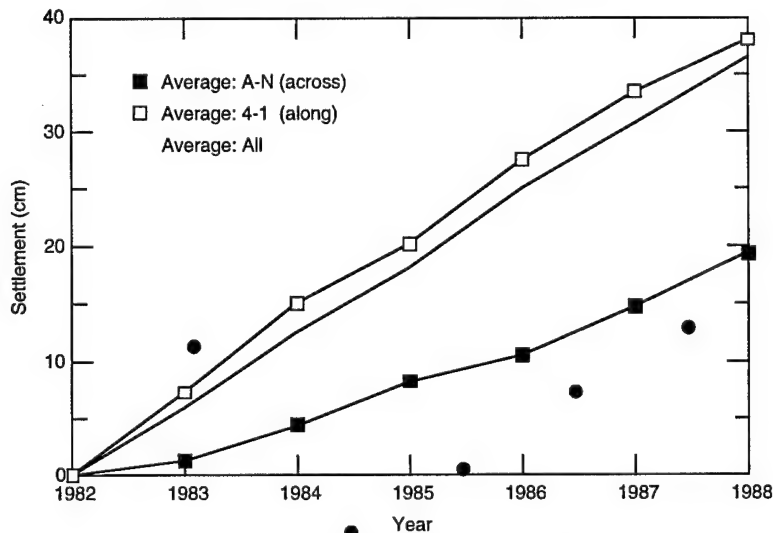
Figure 14. Footing settlement trends.

The across-row settlement as well as the along-row settlements for both rows show similar trends. Figure 14 shows these settlements for the years 1982 to 1988. Along-row settlements were normalized to A4 and N4 for their respective

A3, N3, and N4, we can see how this happens. As A3, N3 and N4 settle relative to A4, the building and truss also settle with respect to A4 at those locations. From Figure 14, the direction and magnitude of the footing tilts averages approximately 300° and 0.014 radians, respectively. The highest loads in the building and truss levels should then be at A4 with intermediate loads at A3 and N4 and the lowest loads at N3. The horizontal loads should be greatest where the settlement is least. Data taken during the 1988 field work confirm both conditions. This also applies to the forward truss.

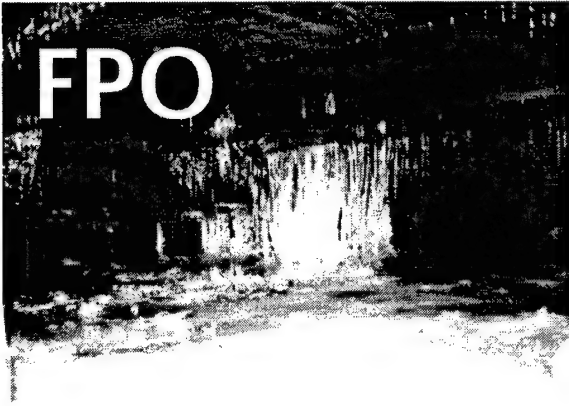
rows while across-row settlements were normalized to the A row. One important note to make here is that in August of 1988 approximately 2 m (6 ft) of water and ice was present in footing N1 (Fig. 15). This was an accumulation of over a meter (4 ft) since June of that year. The effect of the presence of this much water in the column footing may have led to weakening of the underlying packed snow foundation or even voids, depending on the amount of heat given off during the transformation of the water to ice and the contribution of the structural members within the footings to the dissipation of this heat. As the mean annual temperature at DYE-2 is around -16.6°C , there is a good chance some melting of the foundation may have occurred. However, with no borings conducted to verify this hypothesis, we can only postulate that the foundation was adversely affected by the presence of this water.

Figure 15. Flooding of footing N1, August 1988.

base level column load can be found in the opposite corner, at column A4. The presence of a large quantity of water at the base of column N1, covering the footing to a depth of several meters, indicates melting of surface and structural snow and subsequent runoff and collection in the column enclosures. These factors may indicate the cause of the tilt problem at DYE-2: changing snow conditions at the base of the "warm" side footings due to the presence of meltwater. Warmer conditions and the presence of water at the bases of these columns would cause melting or increased densification of the snow beneath these footings, which in turn would undermine the support these columns contribute to the structure. This would contribute to or even cause the differential settlement rates, column and footing tilts, and stress distribution patterns found at DYE-2.

- Footing settlements continued to be a problem. Settlement was linear over the span of time under consideration and showed no indication of slowing. N1 was of special concern due to the amount of water and ice present in the footing room ($\approx 2 \text{ m}$).

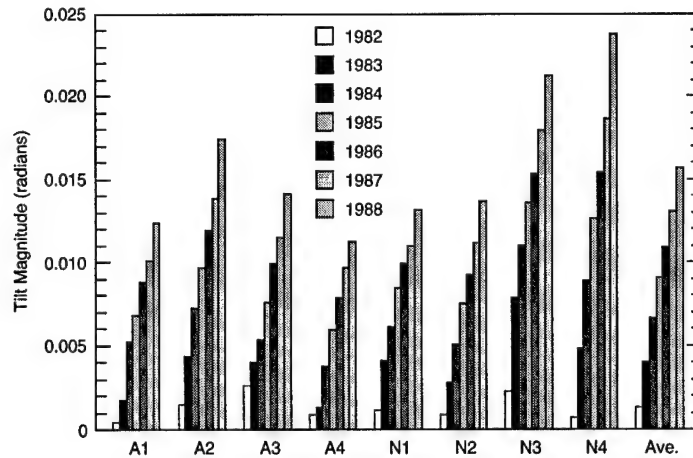
Figure 16. Footing tilts: 1982-1988.

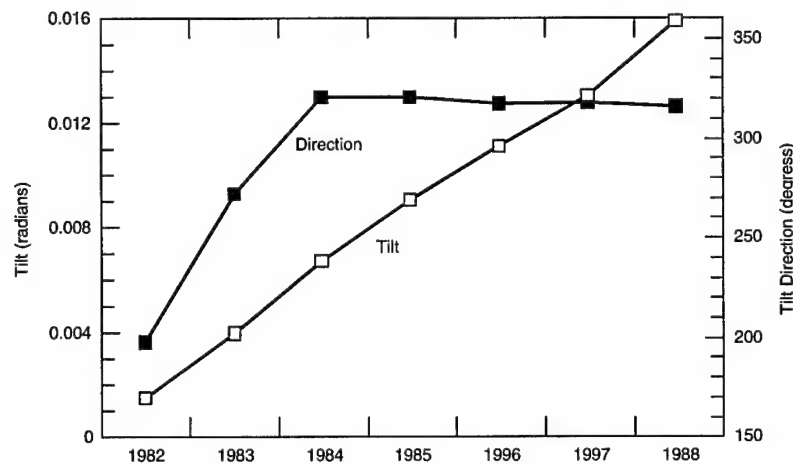
Figure 17. Footing tilt trends.

ern corners (A4 and A2), with the rear truss system (the A4 system) the more heavily loaded. This ultimately affects the base level stress factors.

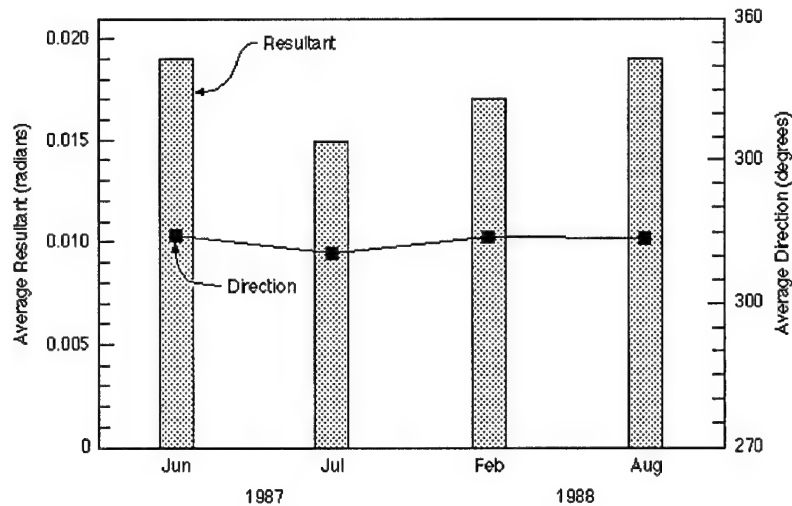
causing the structure to become skewed. Although tilt measurements had only been taken on a regular basis since 1986, the data showed a disturbing trend: the columns were leaning at a rate that increased the out-of-plumbness by about 7 cm per year over a 29-m length. The column tilts affected the stresses experienced by the supporting structure in two ways. Axial loads no longer acted along the central axis of the columns, thereby generating moment loads at the base of the column where it attaches to the footing structure. Thus the angle between column and footing tilted. In addition, horizontal stresses are introduced at the truss connections (sway bolt locations) because of twisting forces on trusses. These were the static structural forces that were measured to determine the column stresses.

Figure 18. Column tilt trends.

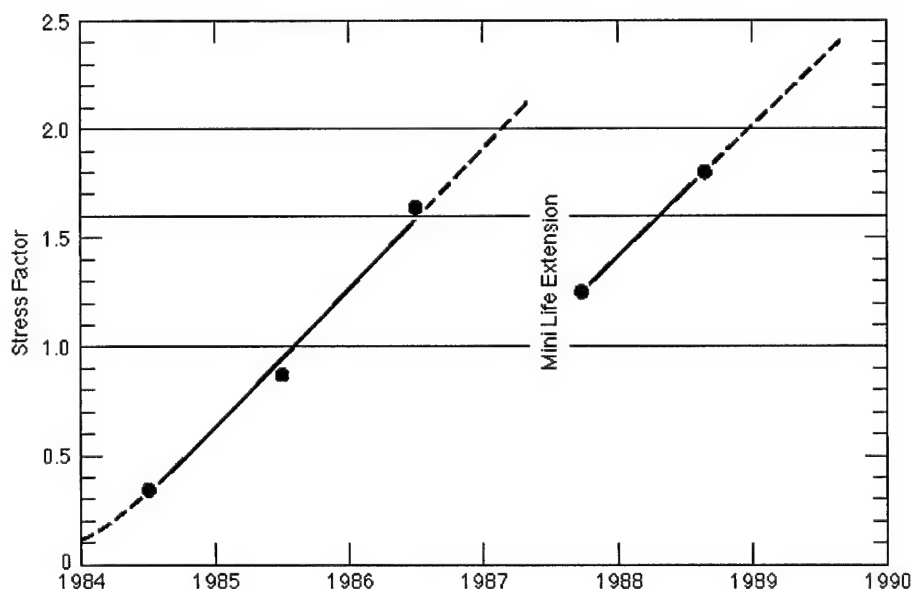
Figure 20. Extrapolation of base level combined stress factors for column A4.

not done. From the data, one can see a rise in the general state of stress in the structure, especially in column A4, which has a combined stress factor well in excess of 1.60. Extrapolation of this and previous years' data indicated a combined stress factor of more than 2.00 by year's end (Fig. 20).

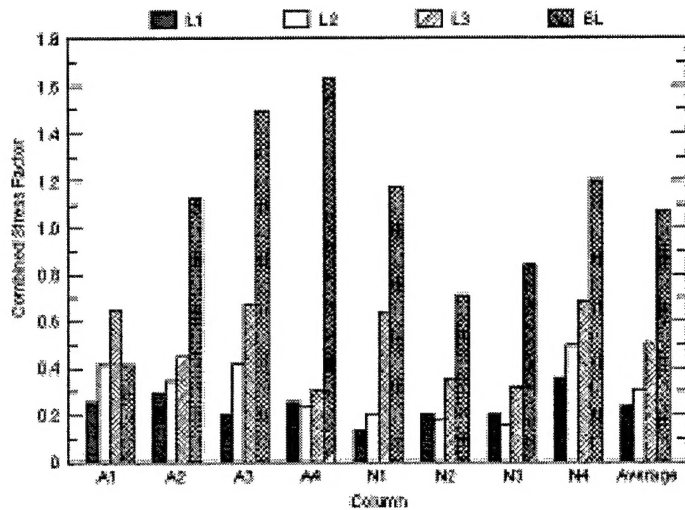
Figure B4 contains the third complete set of combined stress factors since the move in 1982. It is interesting to compare stress factors for 1984 through 1986 for trends. High stress concentration factors in general, and especially at column A4 (>1.60), led to a recommendation that work be contracted for the next summer to alleviate some of the high stresses. Column tilts were also a factor in this decision.

Figure B4. Swaybolt loads: 1986.

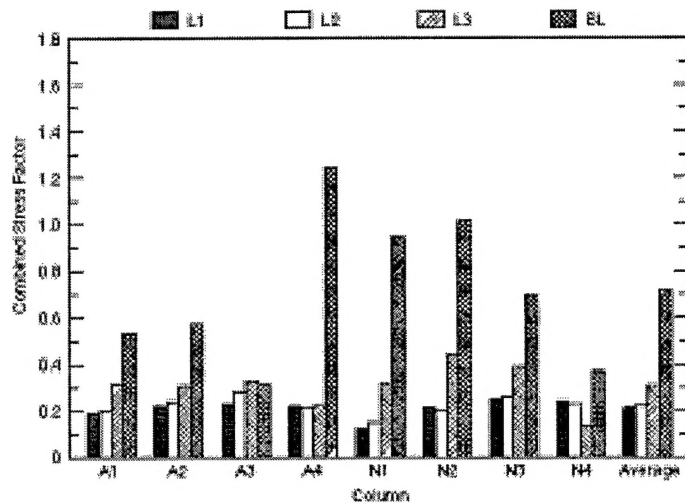
Figure B5 contains the fourth complete set of combined stress factors since the move in 1982 and the first since the mini-life-extension of 1987. Comparing stress factors for 1984 through 1987 points up several trends that are more obvious when examining Figure 12. Although the mini-life-extension served to lower most stress and redistribute stresses among the columns in general, trends dictated a repeat of the work performed in 1987 to assure the structural integrity of the building. Another mini-life-extension was therefore recommended for 1988.

Figure B5. Swaybolt loads: 1987.

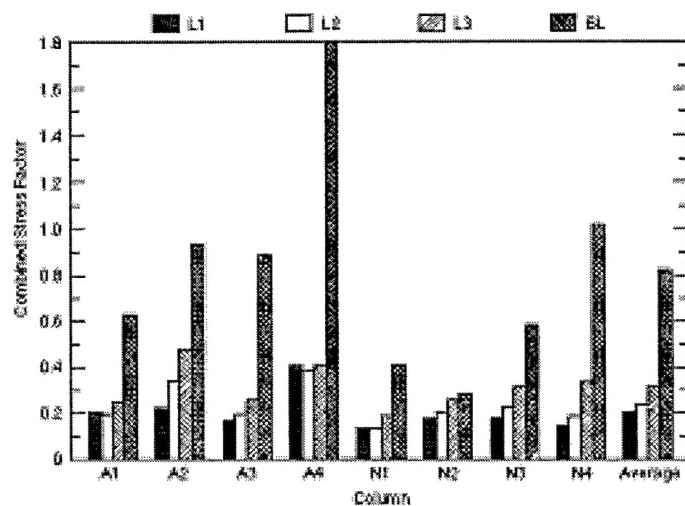
Figure B6 contains the final complete set of combined stress factors calculated for DYE-2 and the second since the mini-life-extension of 1987. Comparing stress factors for 1984 through 1988 points up several trends which are more obvious when examining Figure 12. Although the mini-life-extension was recommended for the summer of 1988, funding difficulties were encountered and the work was

Figure B6. Swaybolt loads: 1988.
